Milestone Phase I Report
Lakeside Crossing Condominium Association, Inc.

Per your request, a team from Stone Building Solutions, LLC (SBS) conducted a Phase 1 Milestone Inspection of the referenced property on the following buildings:

701 S Madison Ave, Clearwater, FL 33756

Project Background

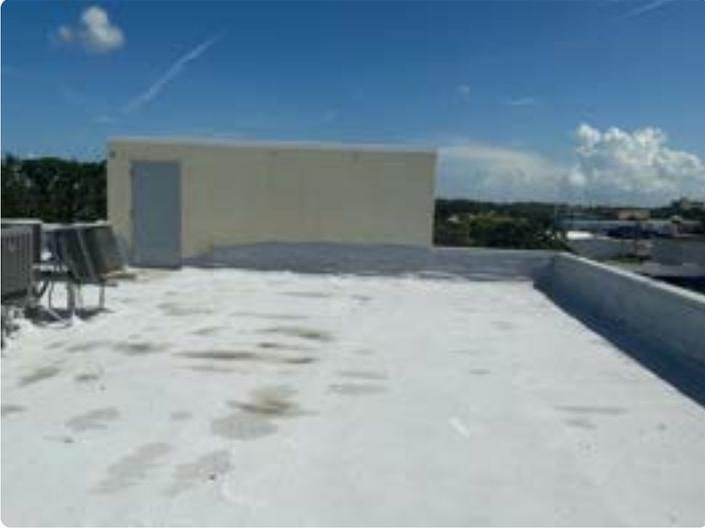
Roof is in good condition

Modified bitumen roof with spray polyurethane foam and a silicone coating.

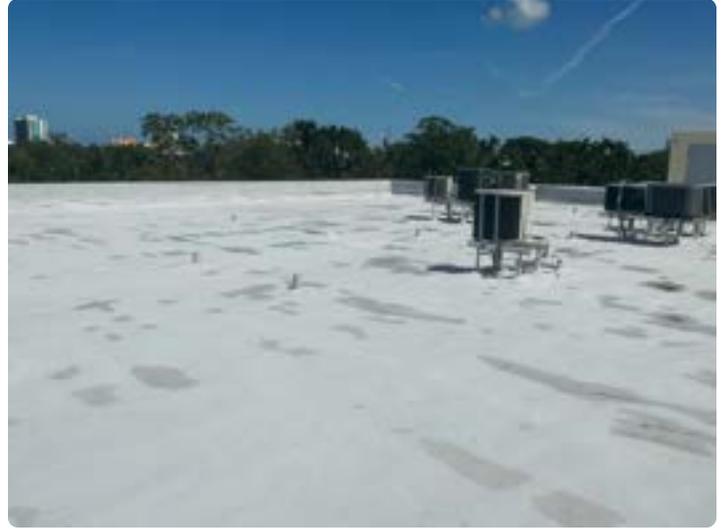
Overview of a modified bitumen roof with spray polyurethane foam and a silicone coating.

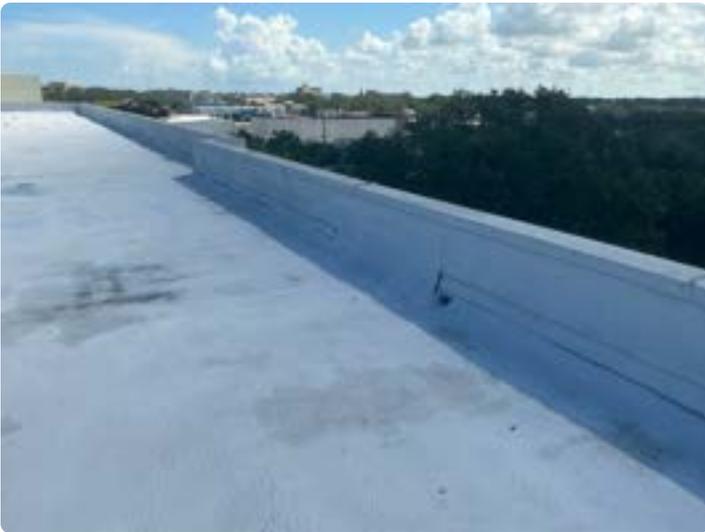
Overview of a modified bitumen roof with spray polyurethane foam and a silicone coating.

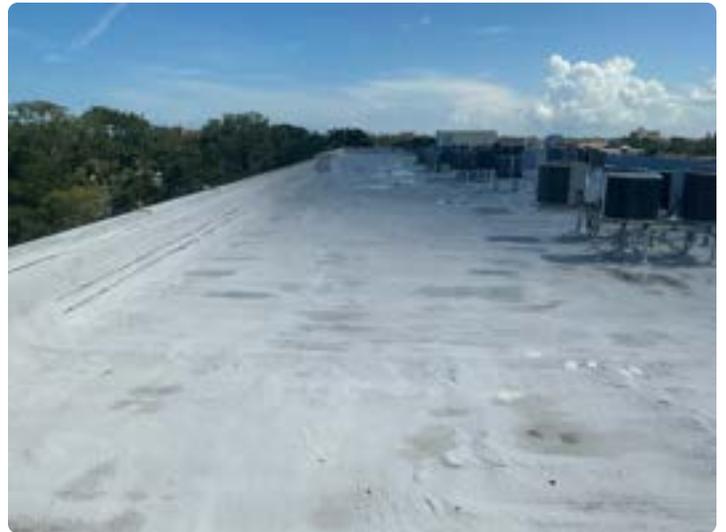
Modified bitumen roof with spray polyurethane foam and a silicone coating.

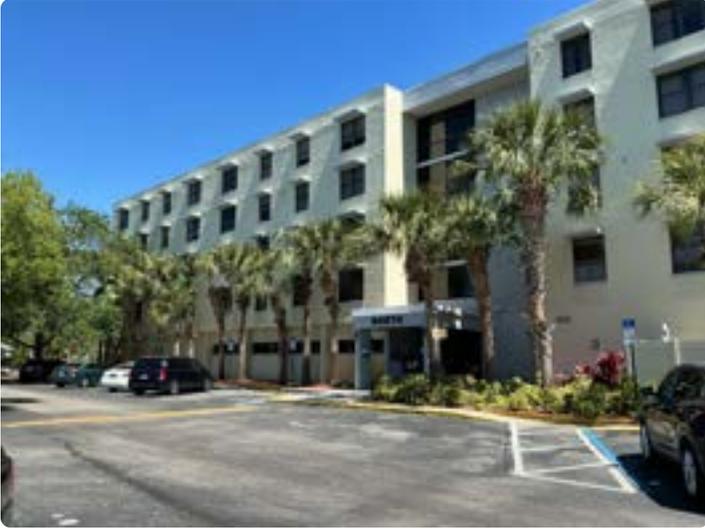
Exterior load bearing walls are in good condition.

Elevation photo, front of building.

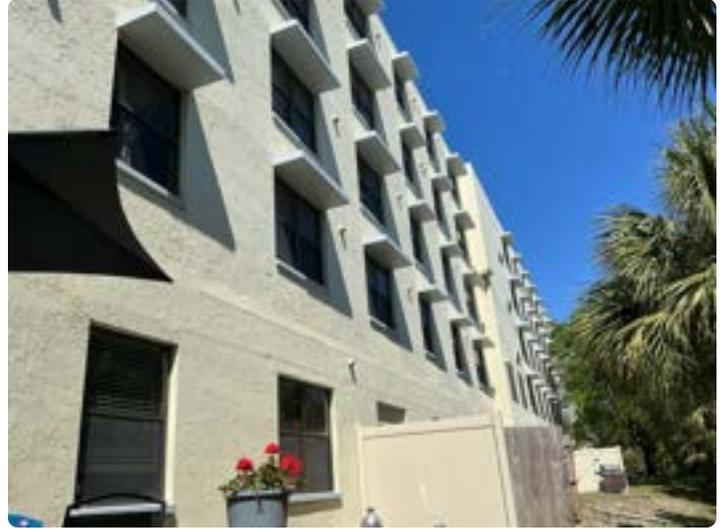
Rear elevation photo.

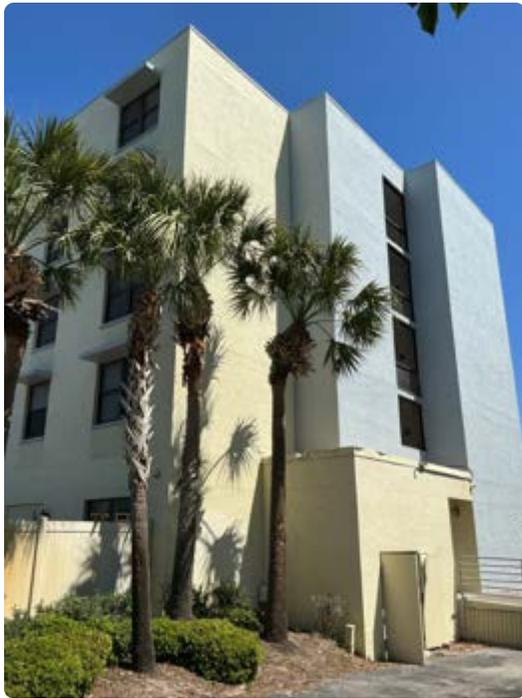
Right elevation photo.

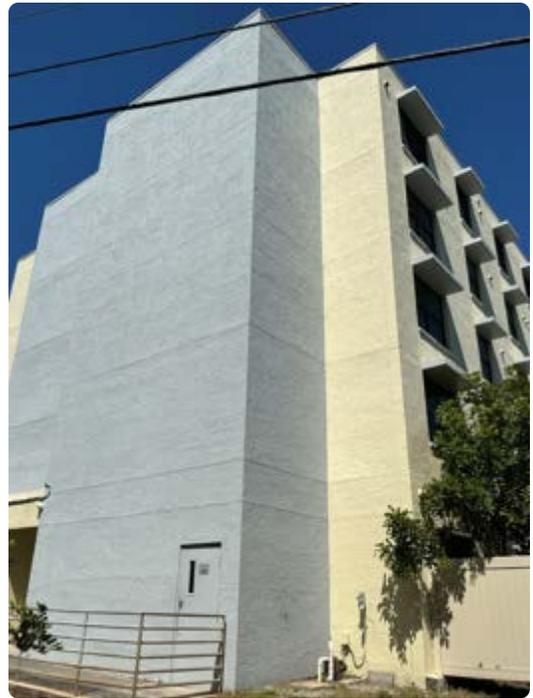
Left elevation photo.

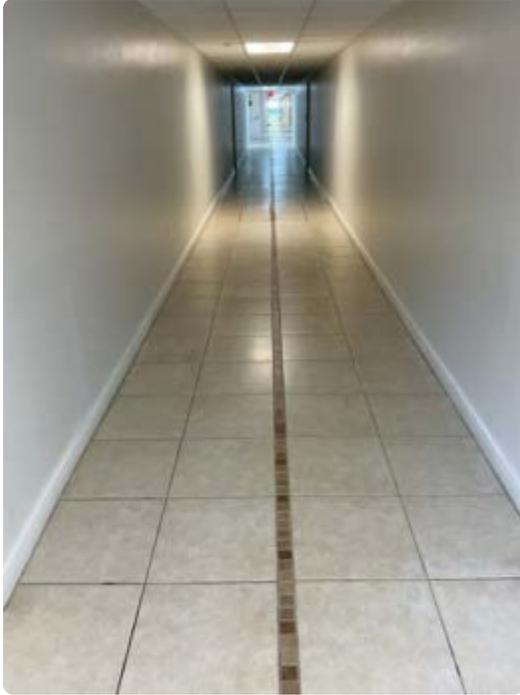
Typical tile walkway.

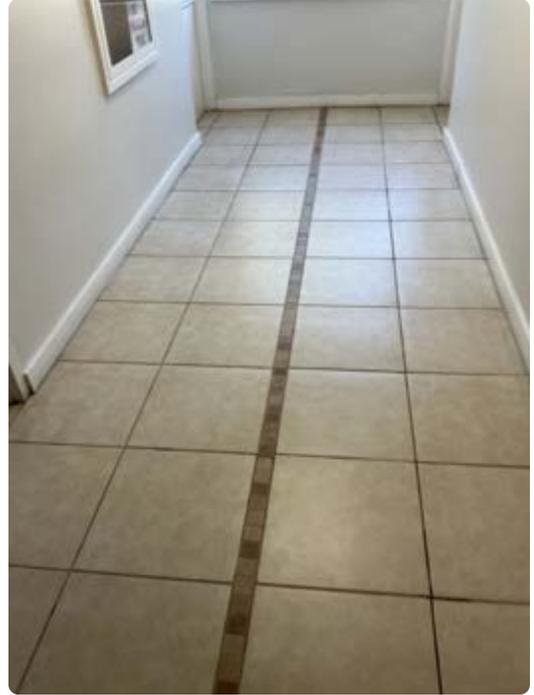
Typical tile walkway.

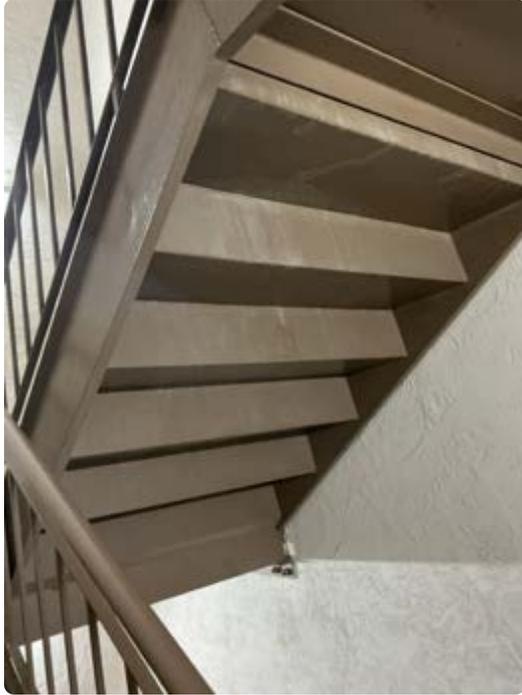
Typical underside of stairwell.

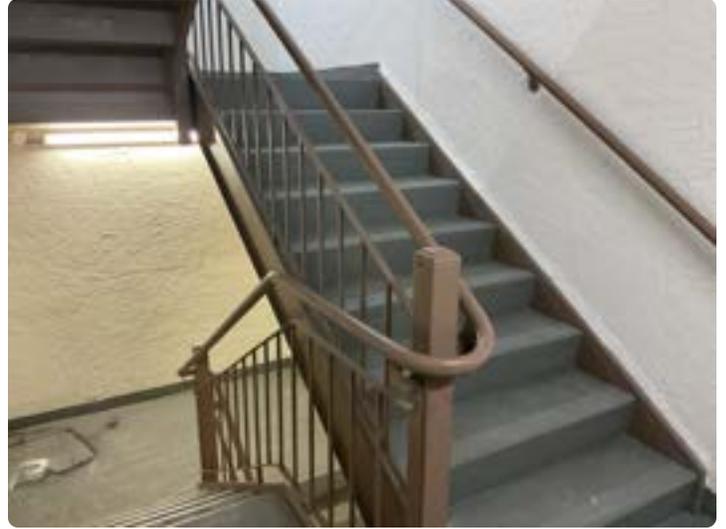
Overview of typical metal stairwell.

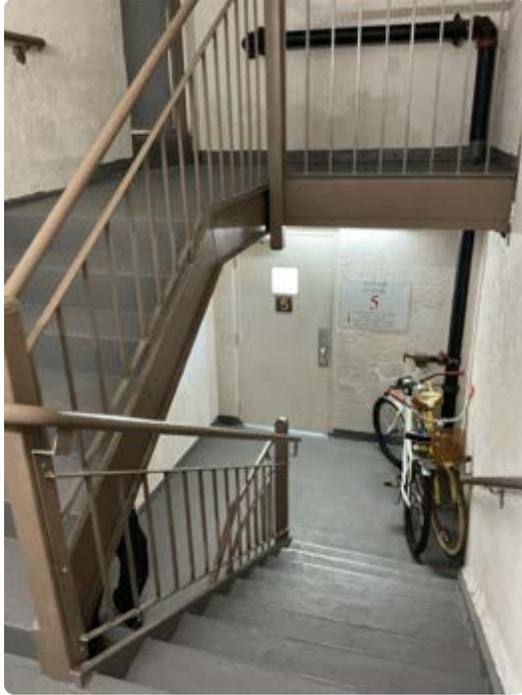
Typical metal stairwell railing.

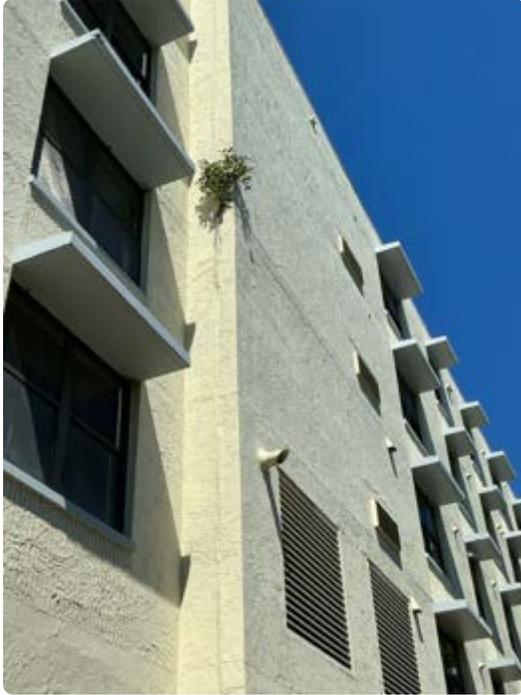
Overview of typical windows properly waterproofed.

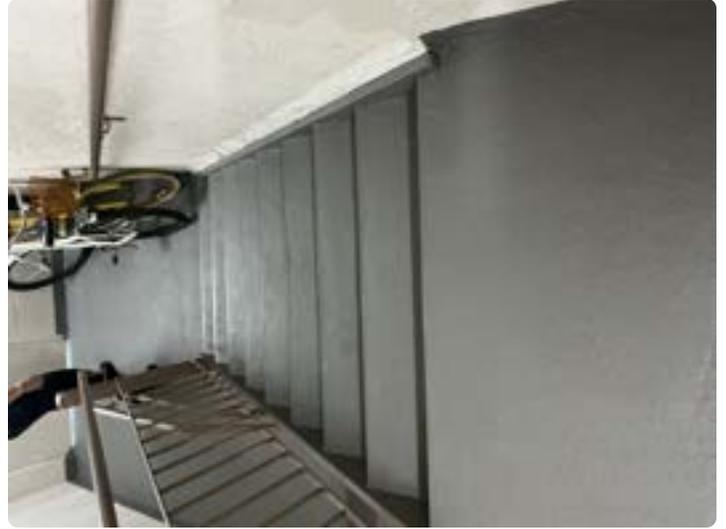
Typical stairwell properly waterproofed.

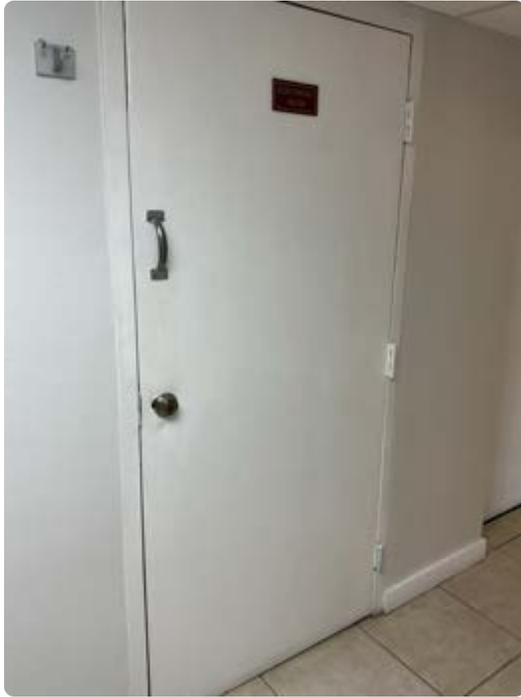
Typical metal common area door.

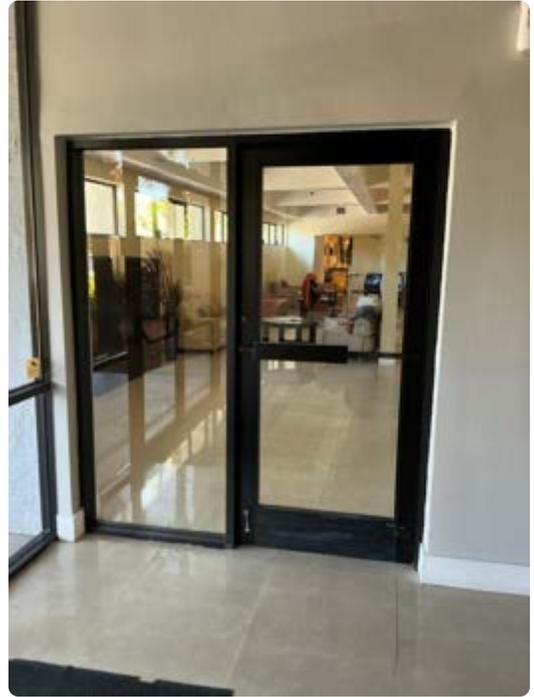
Typical interior common area glass door.

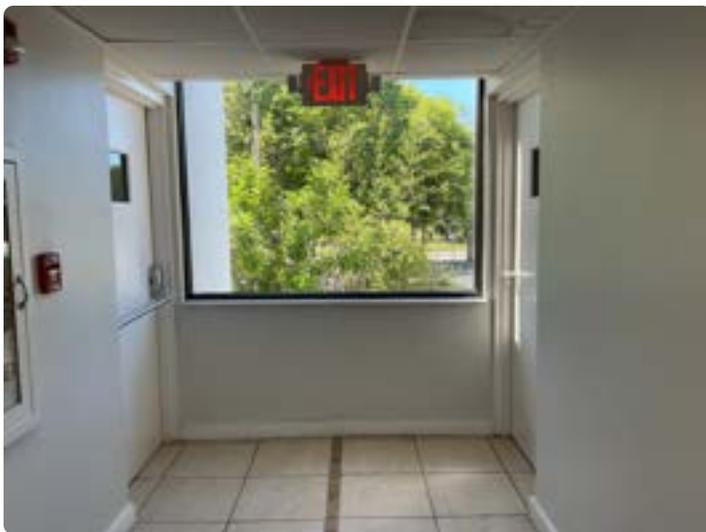
Typical common area window at walkways.
