## Windstorm Mitigation Report (OIR-B1-1802)

Lakeside Crossing Condominium Association, Inc.

701 S Madison Ave, Units 101-116, 201-222, 301-322, 401-422, 501-521

As of 5/26/2022 | FPAT File# MUD2217687

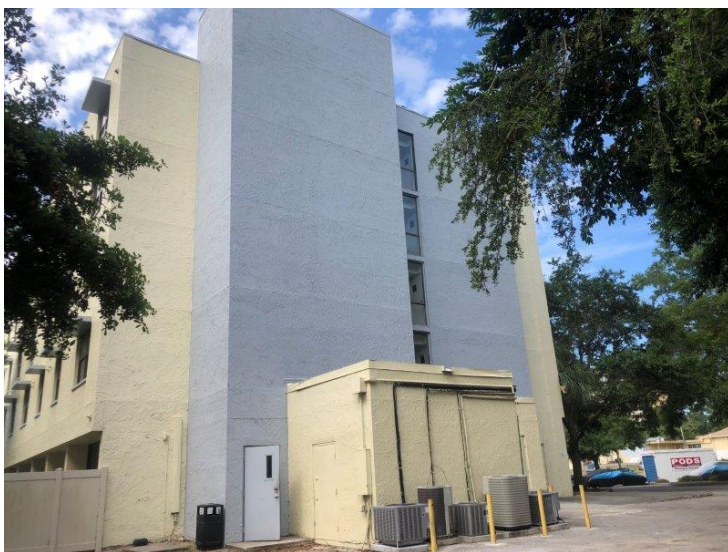
Exterior Elevation

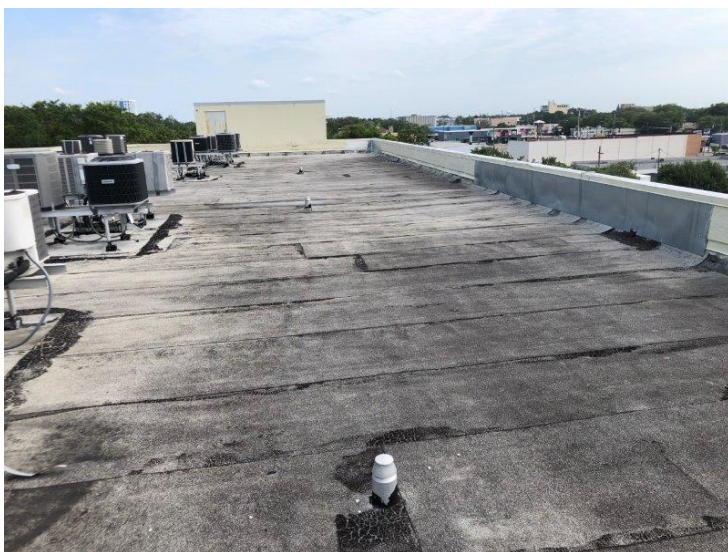
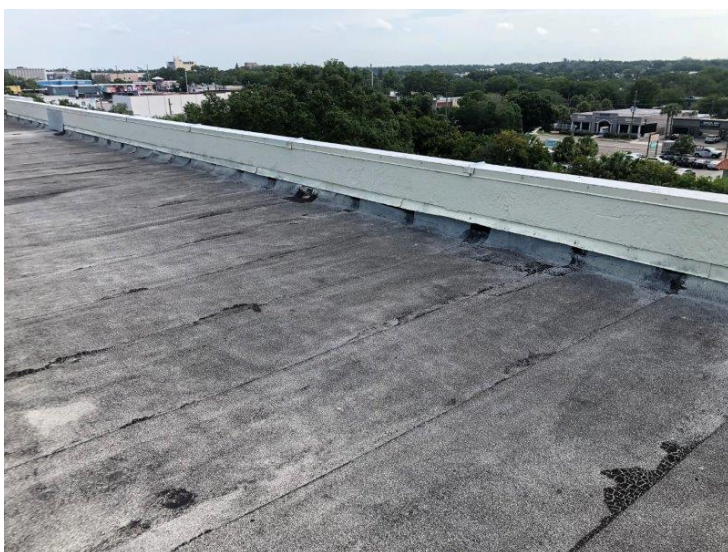
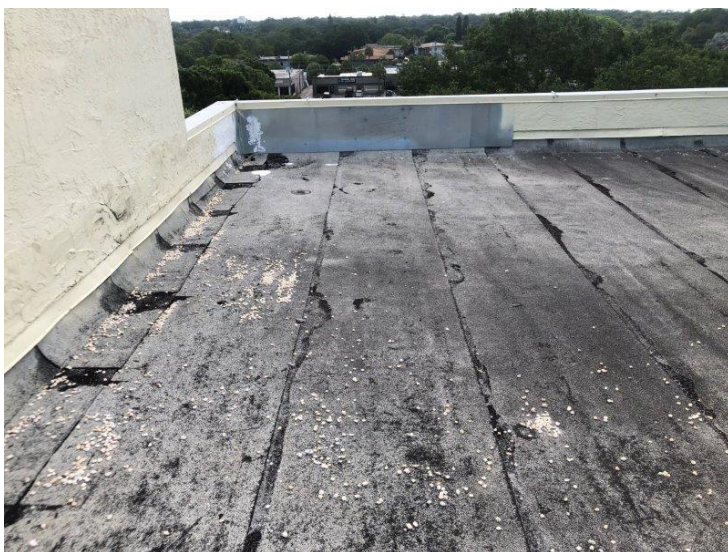
| <b>3. Roof Deck Attachment:</b><br>Comments: | <b>Reinforced Concrete Roof Deck</b><br>Inspection verified a roof structure composed of cast-in-place or pre-cast structural concrete designed to be self-supporting and integrally attached to the wall / support system. |
| <b>5. Roof Geometry:</b><br>Comments: | <b>Flat Roof</b><br>Inspection verified flat roof shape, refer to attached photographs. |

Roof Construction
